RCRA Compliance Evaluation Inspection

Yuasa Battery, Inc.
2901 Montrose Ave.
Laureldale, PA 19605

Dates of Inspection: September 15 & 22, 2009

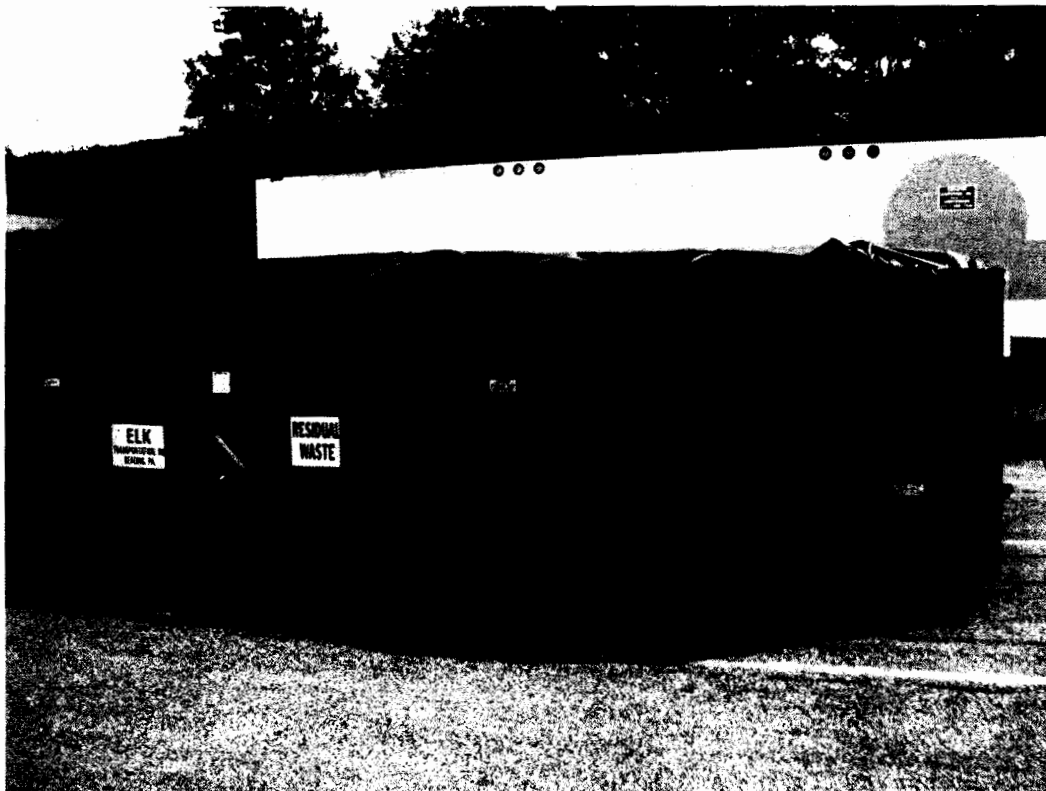
Photograph 1: 30yd² Hazardous Waste roll-off container labeled only as "Residual Waste" with cover open

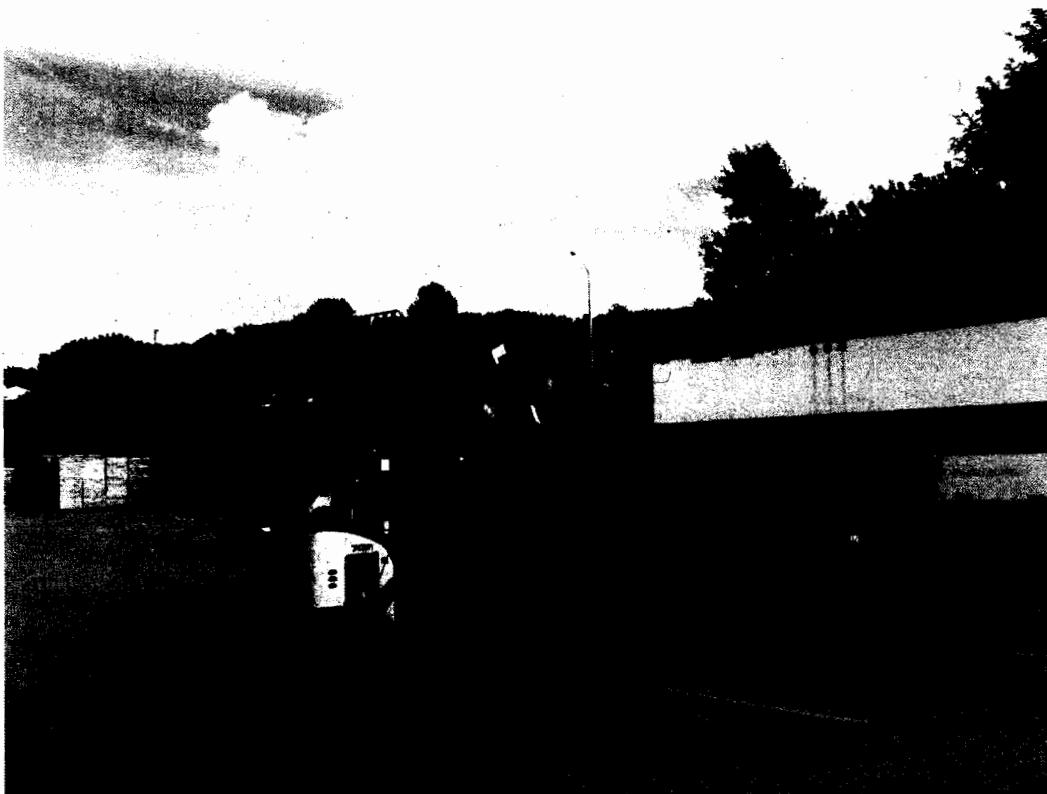
Photo 4: Operator emptying HW hopper into Photo 1 roll-off during inspection (hopper contained PPE primarily)

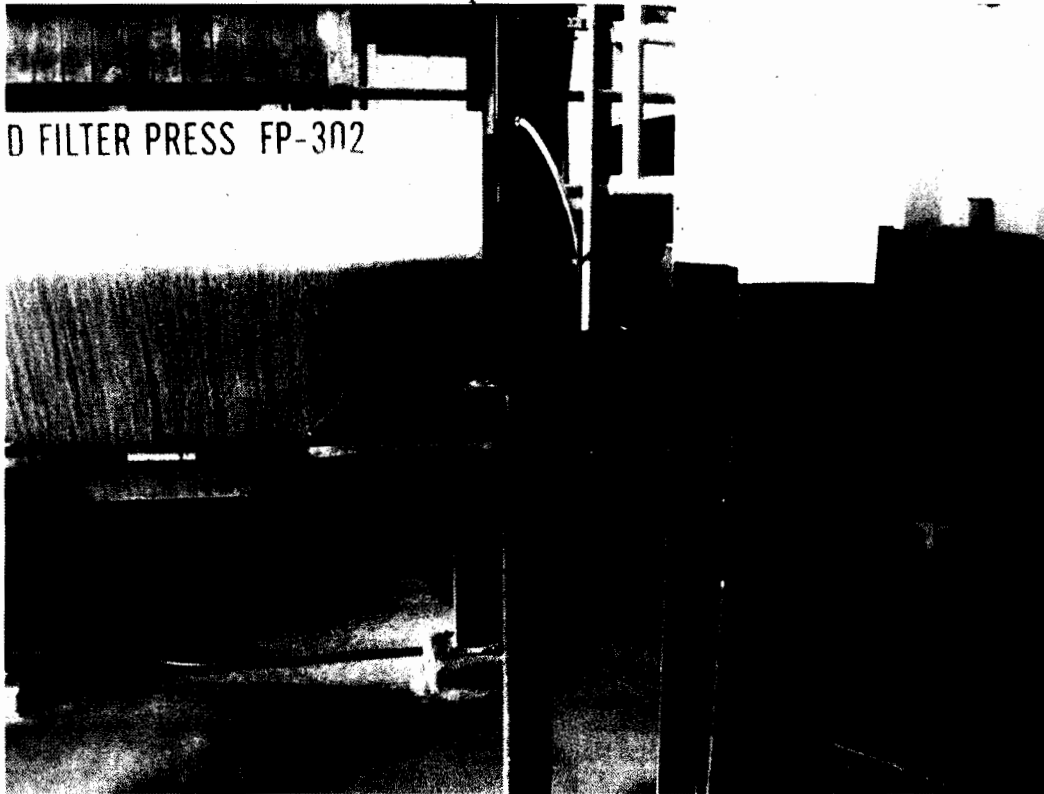
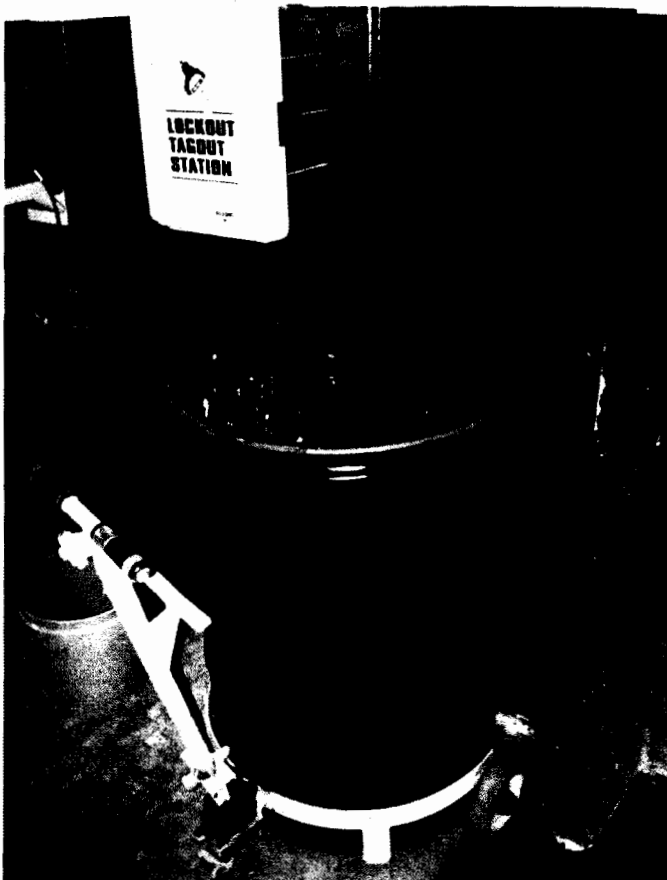
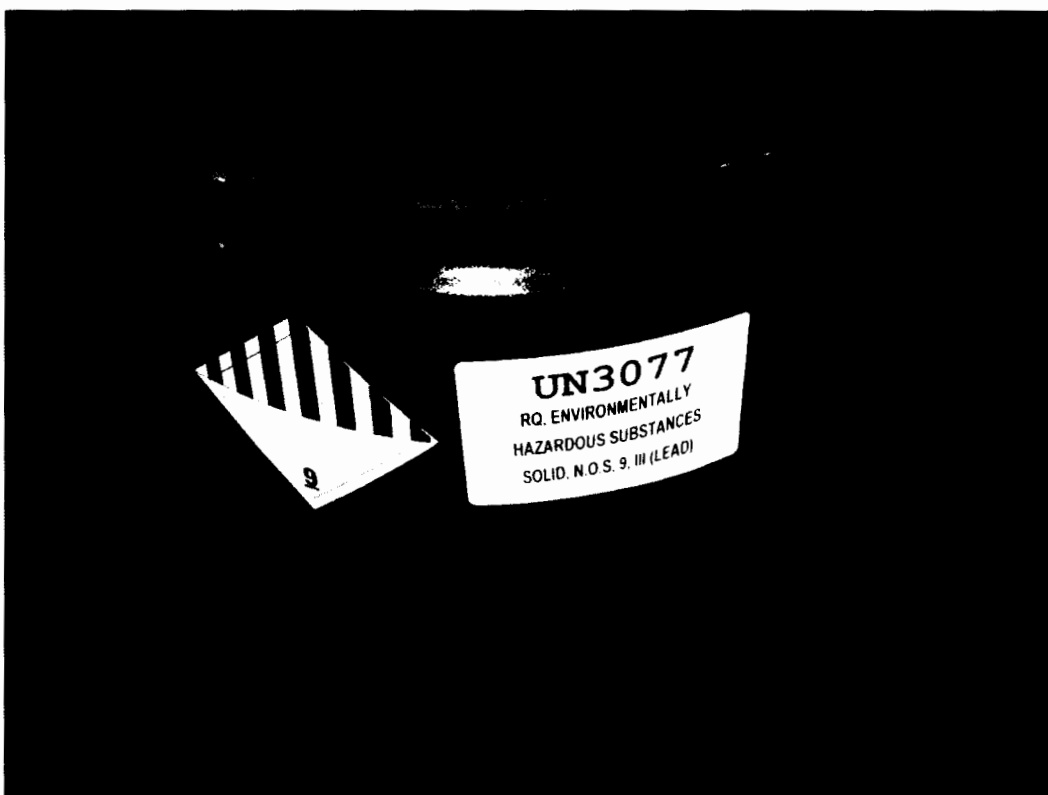
An open 55gal drum was found near the output chute for filter press "FP-302" containing what was described as "lead mud" and labeled as "UN3077 RQ, Environmentally Hazardous Substances, Solid, N.O.S, 9, III (Lead)" (Photos 5-8). On the inspector's subsequent visit Ms. Daub stated that the contents would be sent offsite for reclamation at a lead smelter.

Photo 5: Output of filter press, with open drum in background containing material from press

Photo 6: 55gal drum from Photo 5

Photo 7: View inside Photo 6 drum

Photo 8: Label on Photo 6 drum

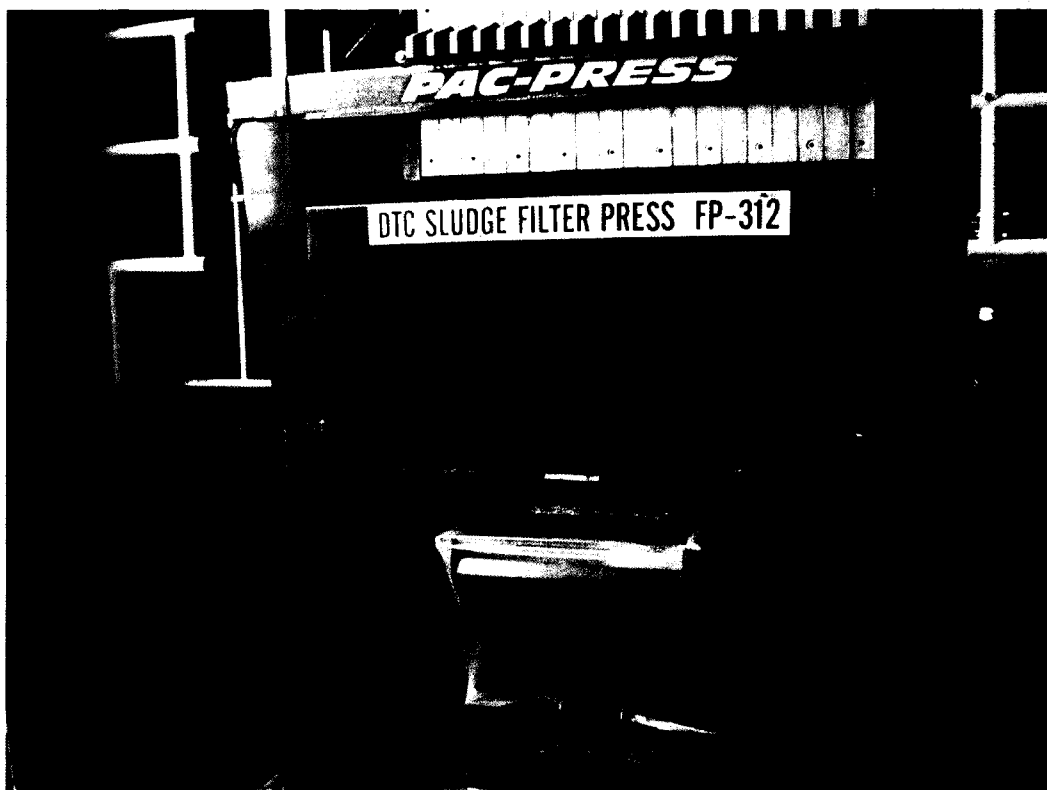
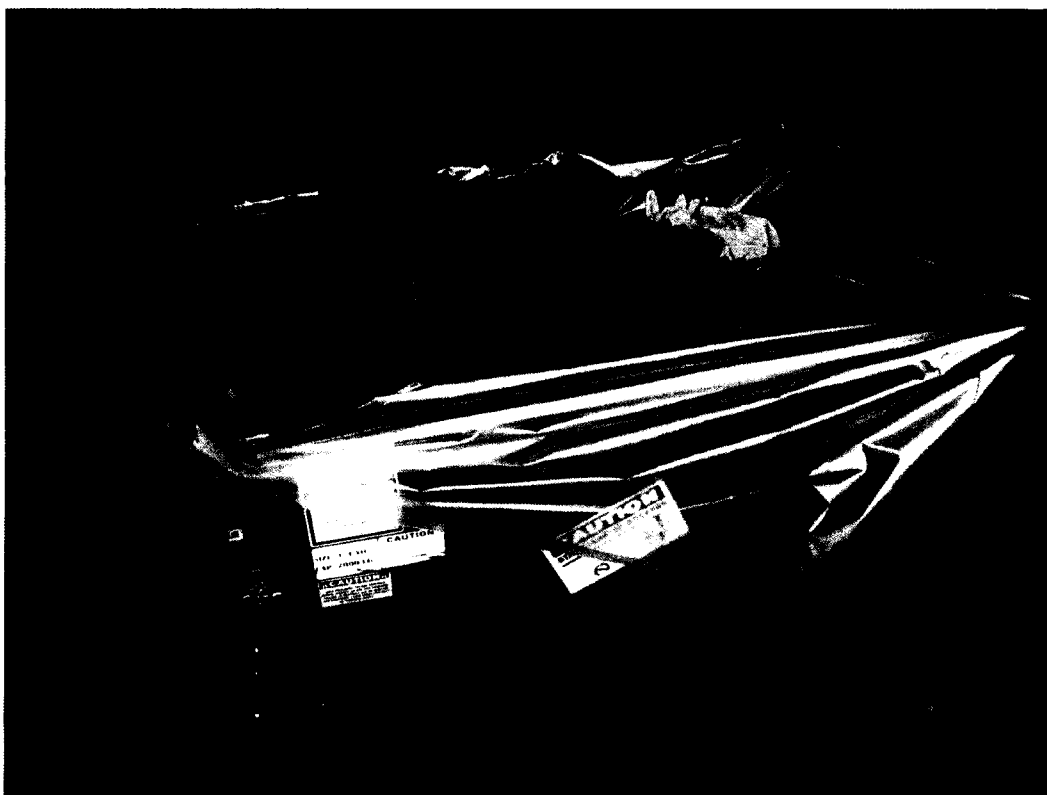
A second filter press ("FP-312") was found nearby with an open, unlabeled cart beneath it containing sludge and used gloves (Photos 9 & 10). The representative stated that this was generated from the microfilter process tank. He further stated that one of these carts would typically be filled per day that the process is running, and that after three or four days the bag liners in each filled cart are zip-tied and the contents dumped into the HW roll-off container outside.

Photo 9: DTC filter press with open cart full of HW sludge underneath

Photo 10: Close-up of cart containing HW sludge -- not labeled as HW

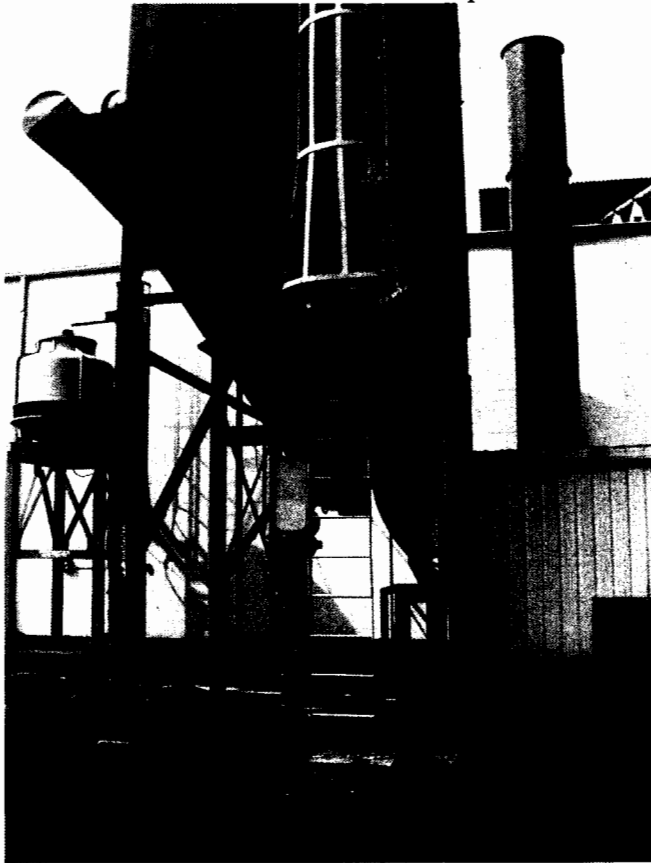
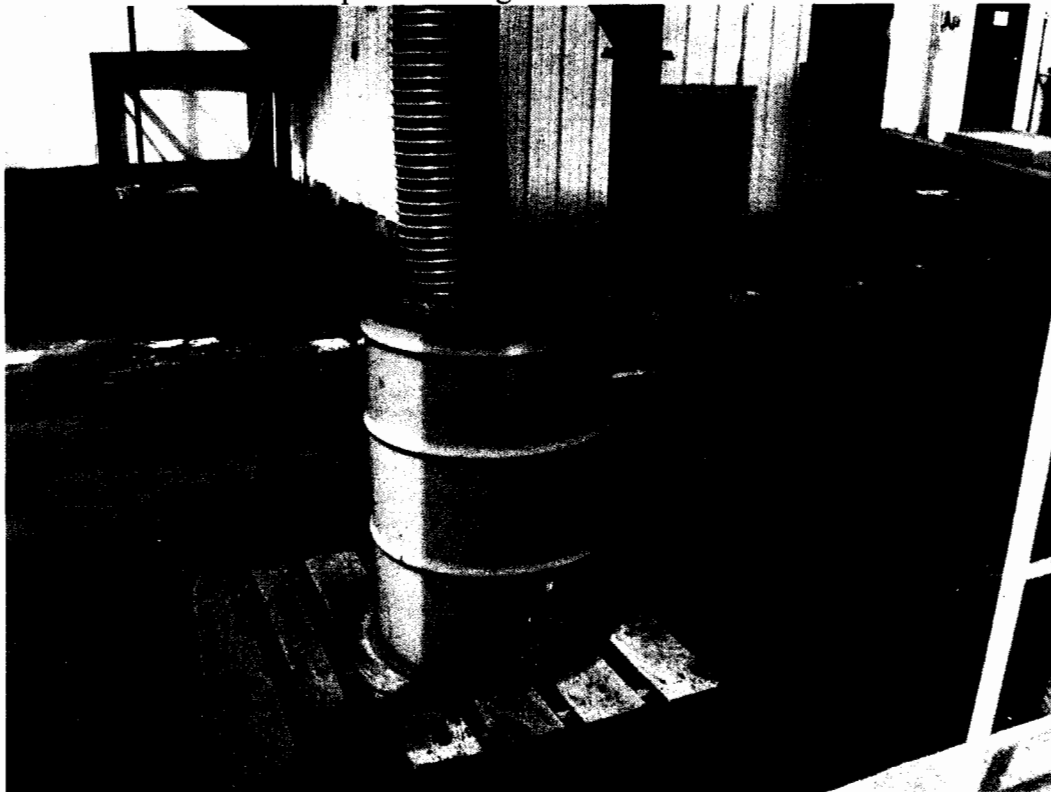
Photo 11: Dust collection point for Baghouse #4

Photo 12: Close-up of drum from Photo 11

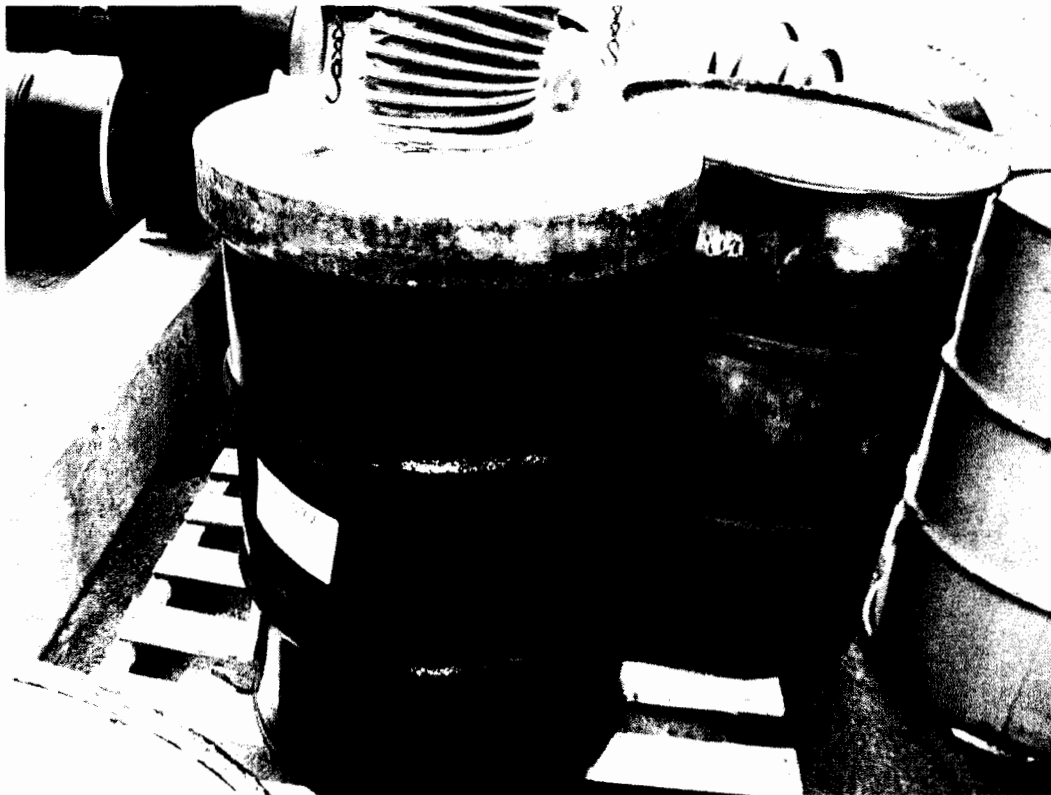
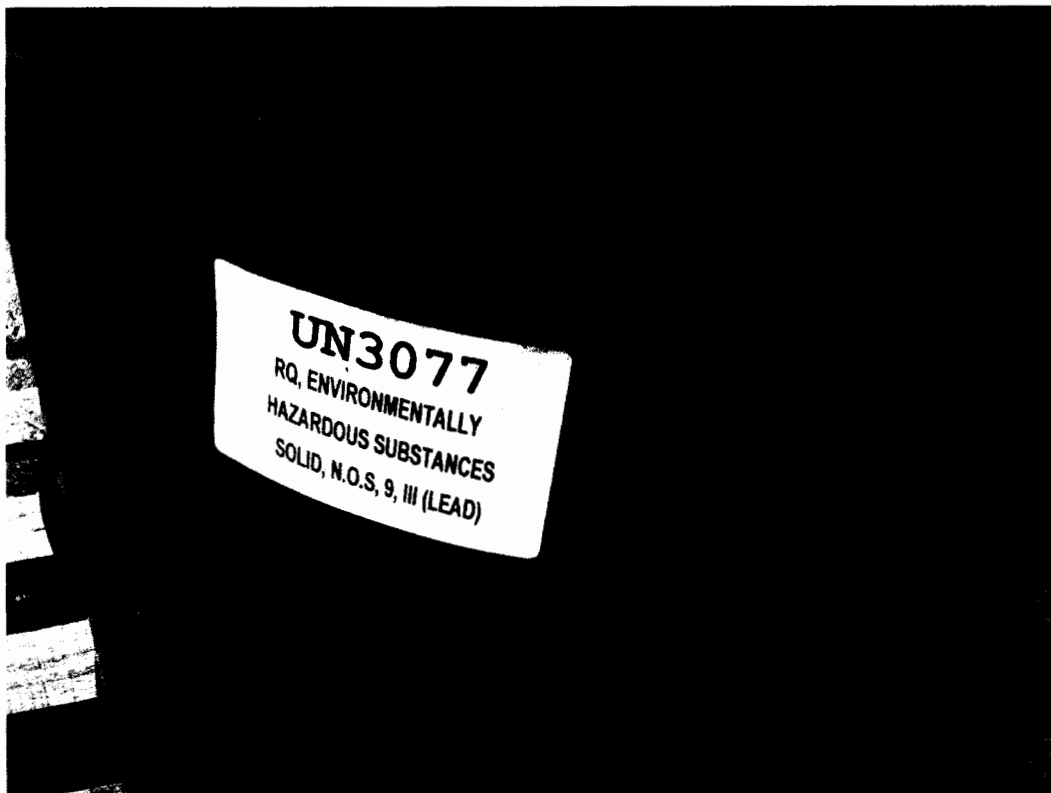
Photo 15: Dust collection point for Baghouse #2

Photo 16: Close-up of label on Photo 15 drum

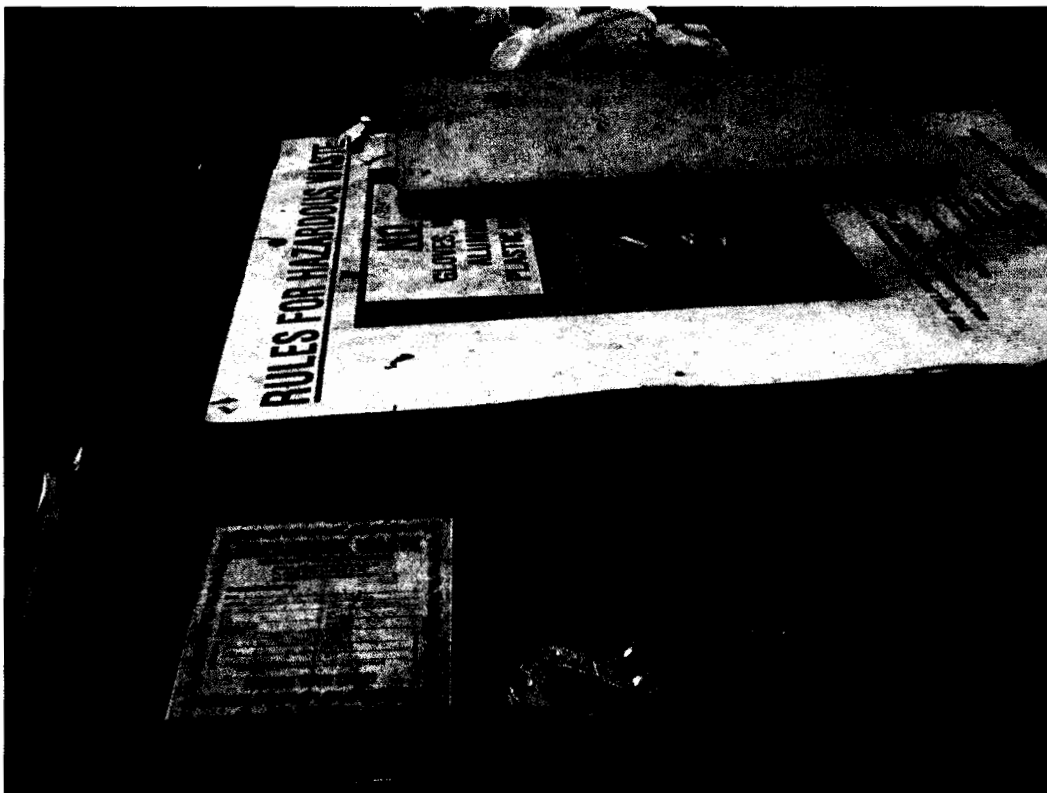
An open, undated hopper was found in the Grid Casting Area, labeled as HW and full of what appeared to be spent PPE and towels inside a plastic liner (Photos 17 & 18). The representative stated that when full the bag would normally be removed and placed into the HW roll-off container outside. Several of these hoppers were found throughout the facility, as described below, and were labeled as being one cubic yard/2,000 pound capacity.

Photo 17: Hopper in Grid Casting area -- open, labeled as HW, not dated

Photo 18: Labels seen on top of Photo 17 hopper

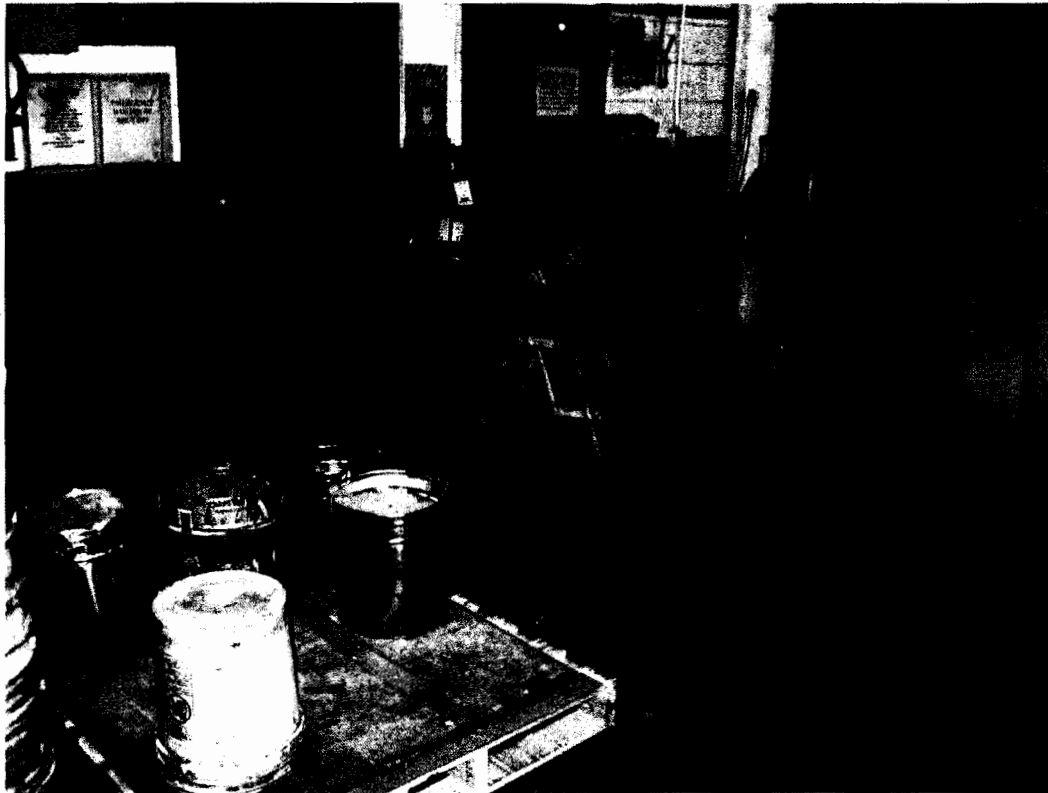
Four open buckets of dross were also found in this area (Photo 19). Mr. Richards stated

Photo 19: Four open buckets containing dross in Grid Casting area

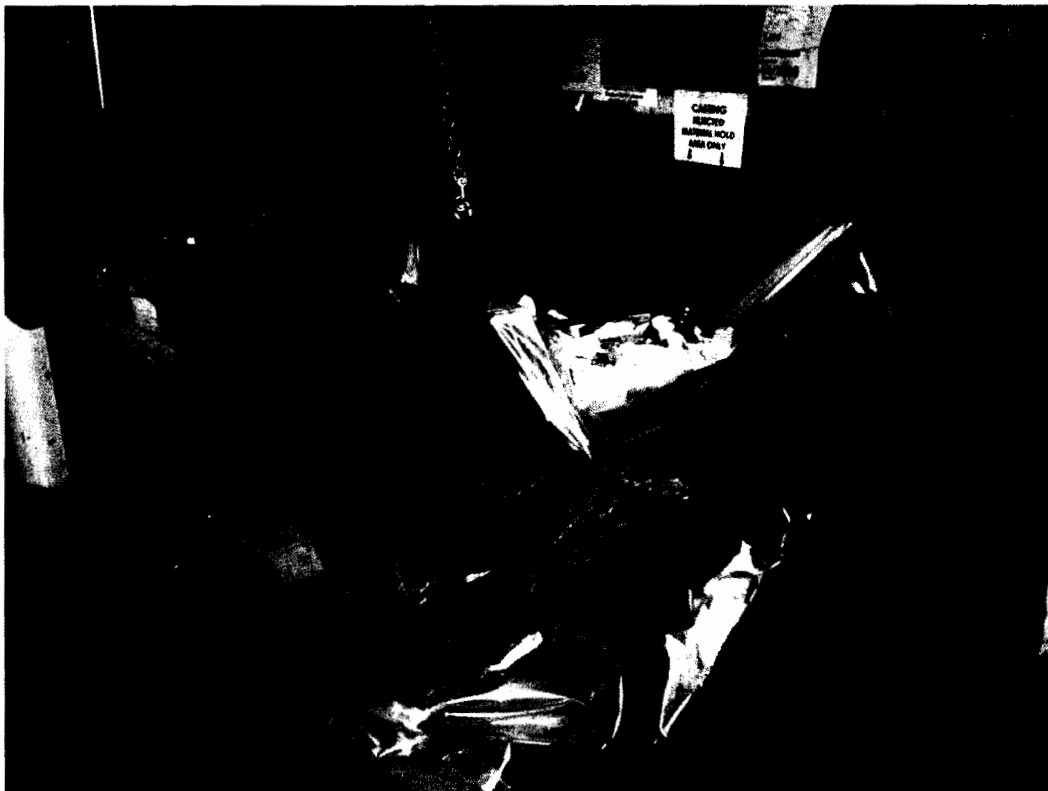
Photo 20: Open HW hopper in Grid Storage/HW Room

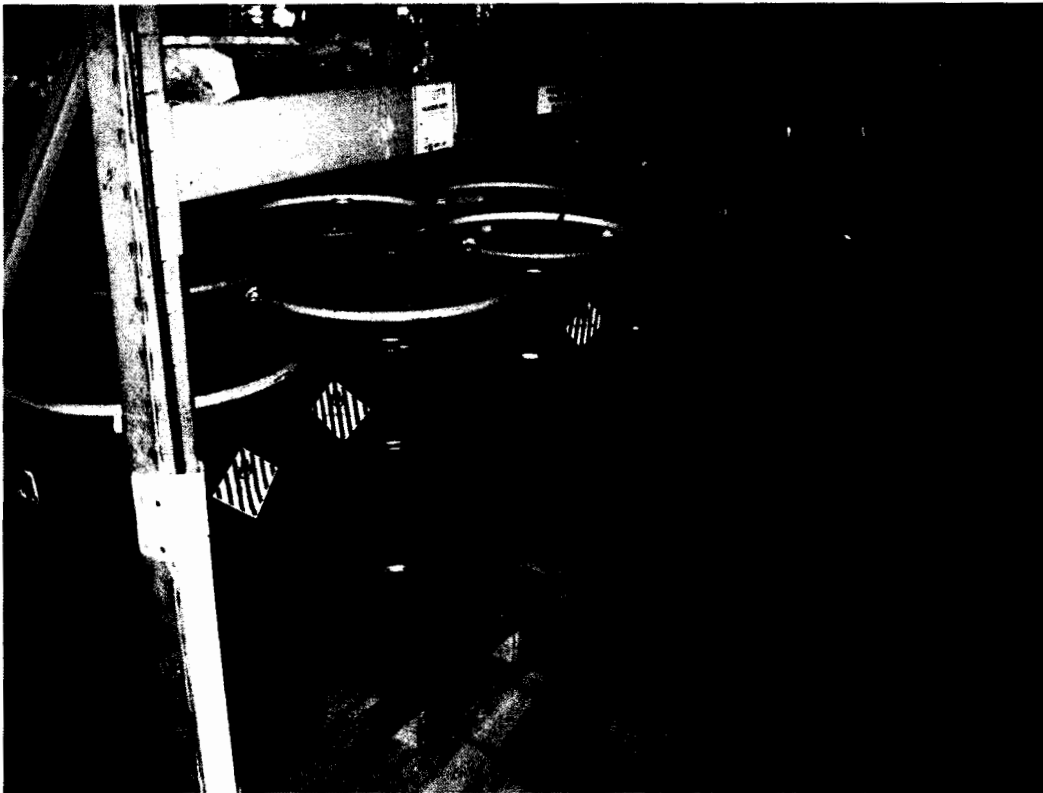
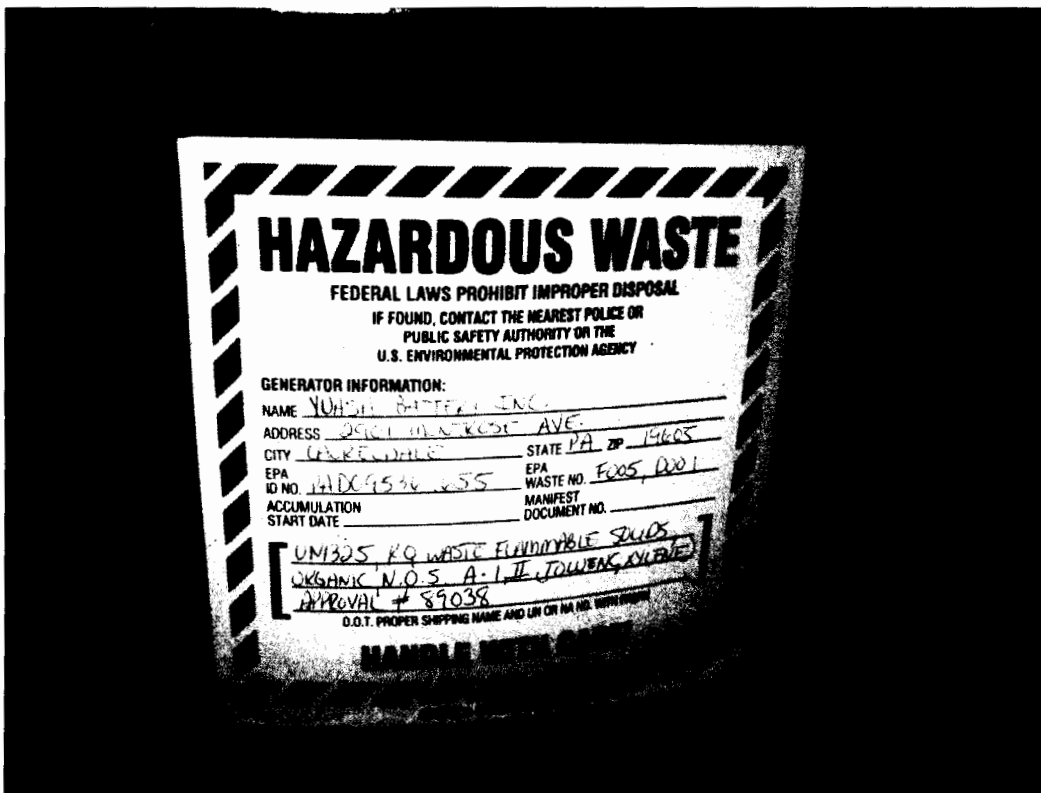
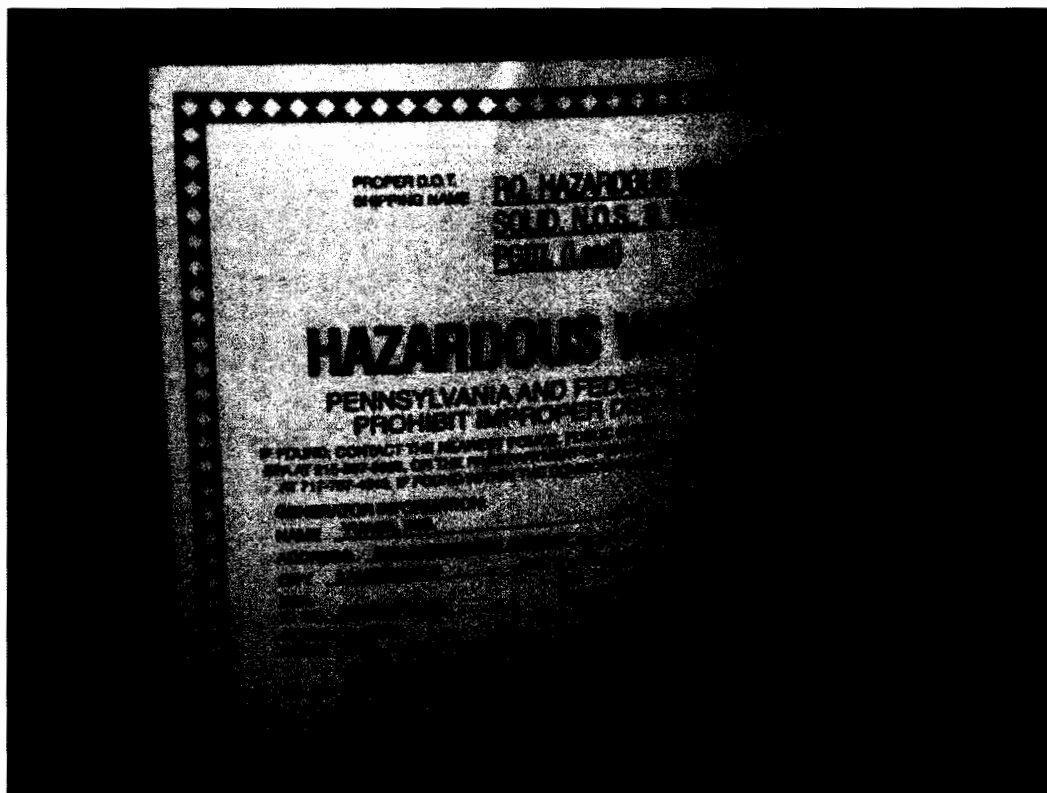
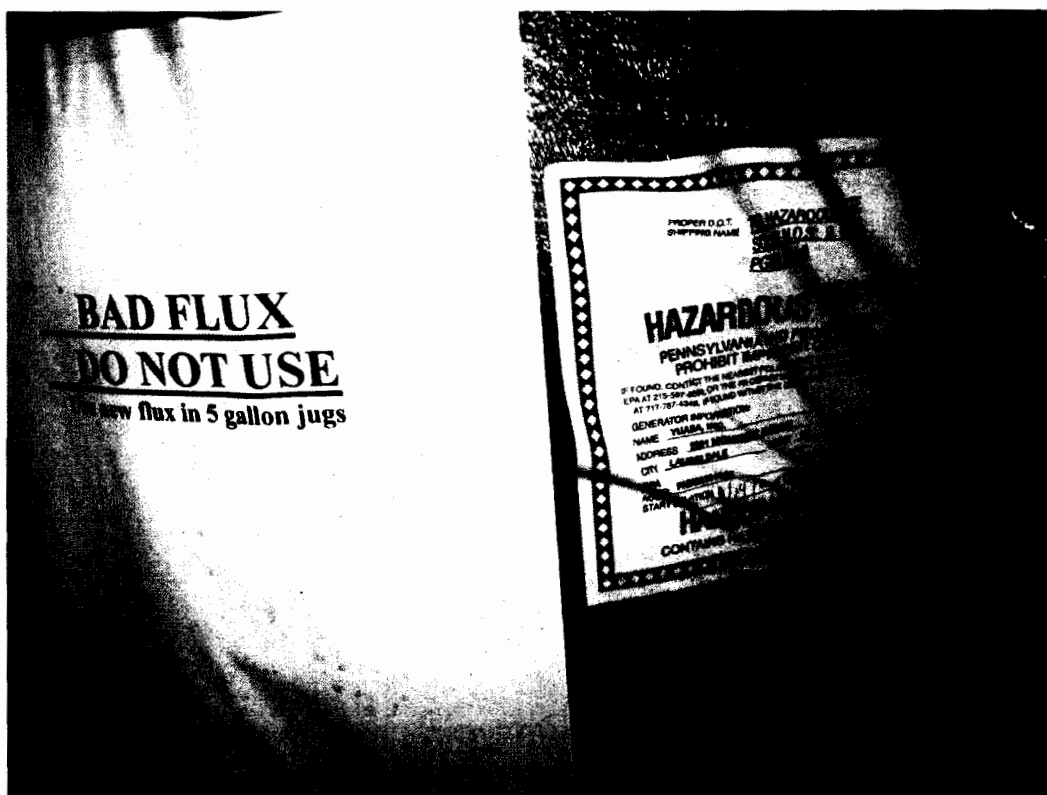
Twelve 55gal drums of HW were found against the wall of this room, nine of which were black and labeled as containing flammable solids, toluene and xylene (Photos 21 & 22). The three remaining drums were blue and labeled as containing D008 material (Photos 21, 23 & 24). All of the black drums and one of the blue drums were undated.

Photo 21: Twelve 55gal drums of HW in Grid Storage/HW Room (front 10 undated)

Photo 22: Close-up of label on leftmost drum from Photo 21 -- no date

Photo 23: Close-up of label on leftmost blue drum from Photo 21 -- no date

Photo 24: Close-up of label from one of two rightmost drums in Photo 21, both dated

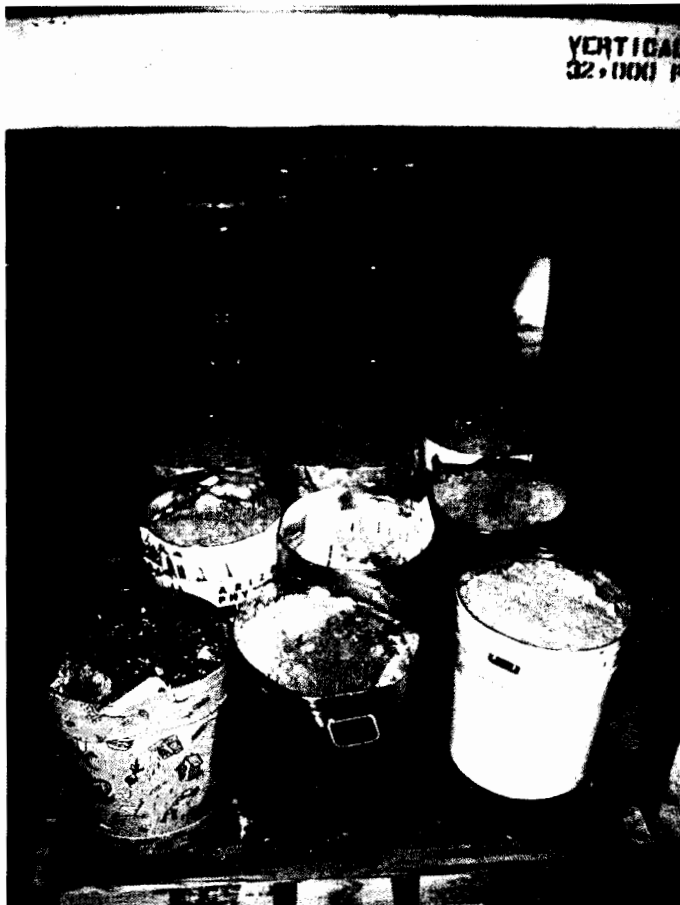
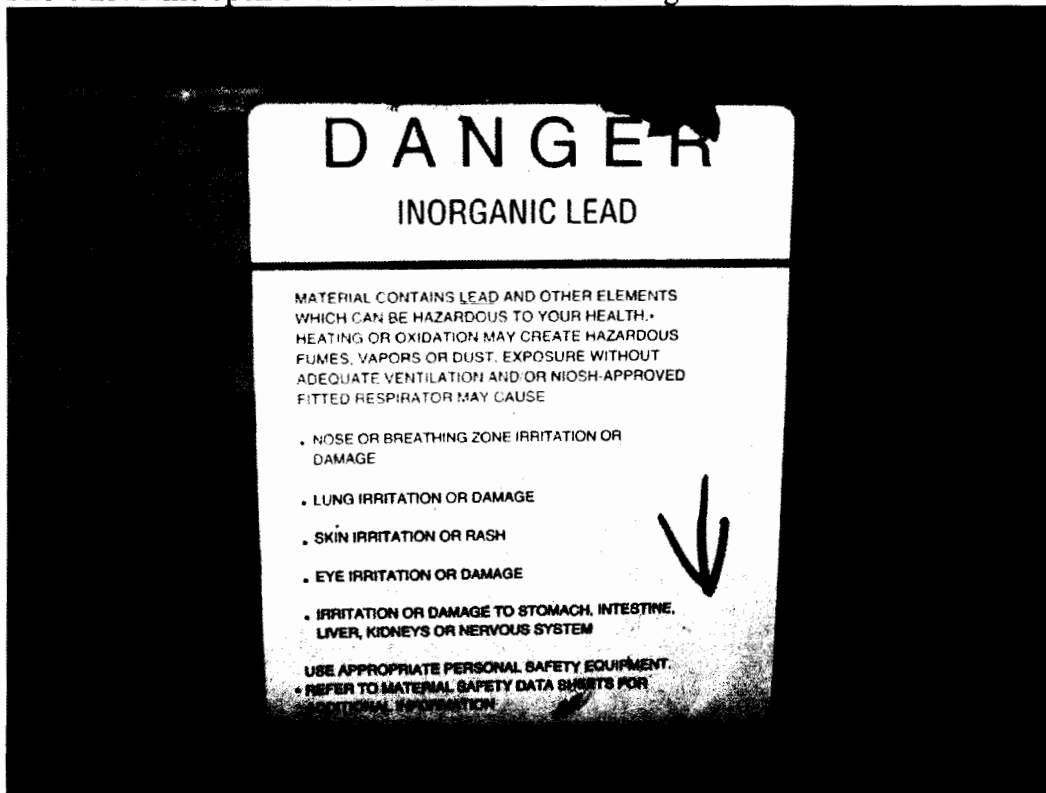
At the end of this aisle, nine open buckets of dross were also found (Photo 25). The buckets were labeled as containing inorganic lead (Photo 26) but not otherwise labeled or dated. On September 15 the inspector was told these buckets would be disposed of as HW, but Ms. Daub later specified that they were not considered HW and would be sent off for recycling.

Photo 25: Nine open buckets of dross in Grid Storage/HW Room

Photo 26: Close-up of label on dross buckets from Photo 25

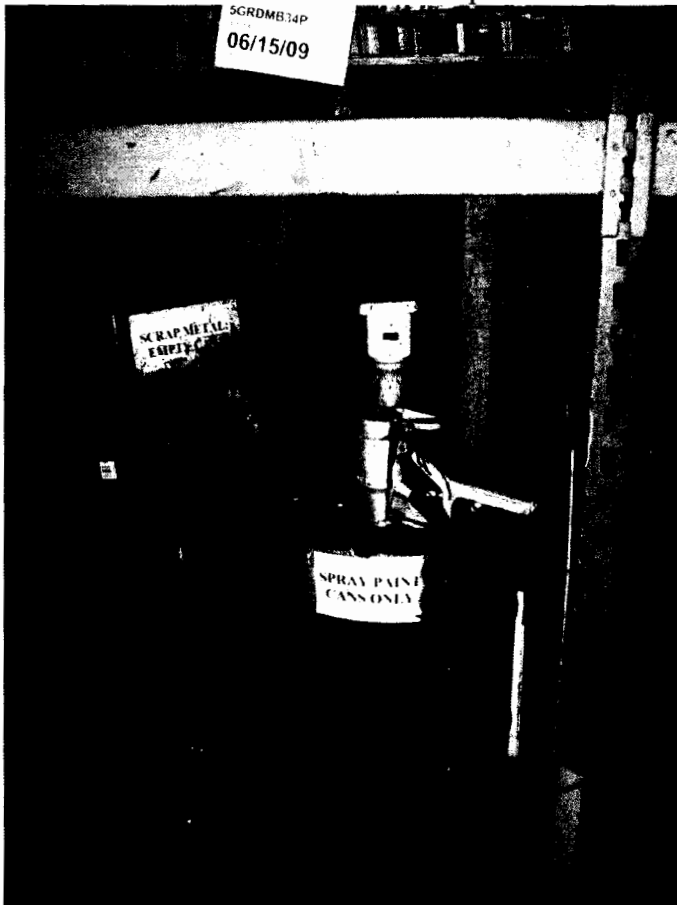
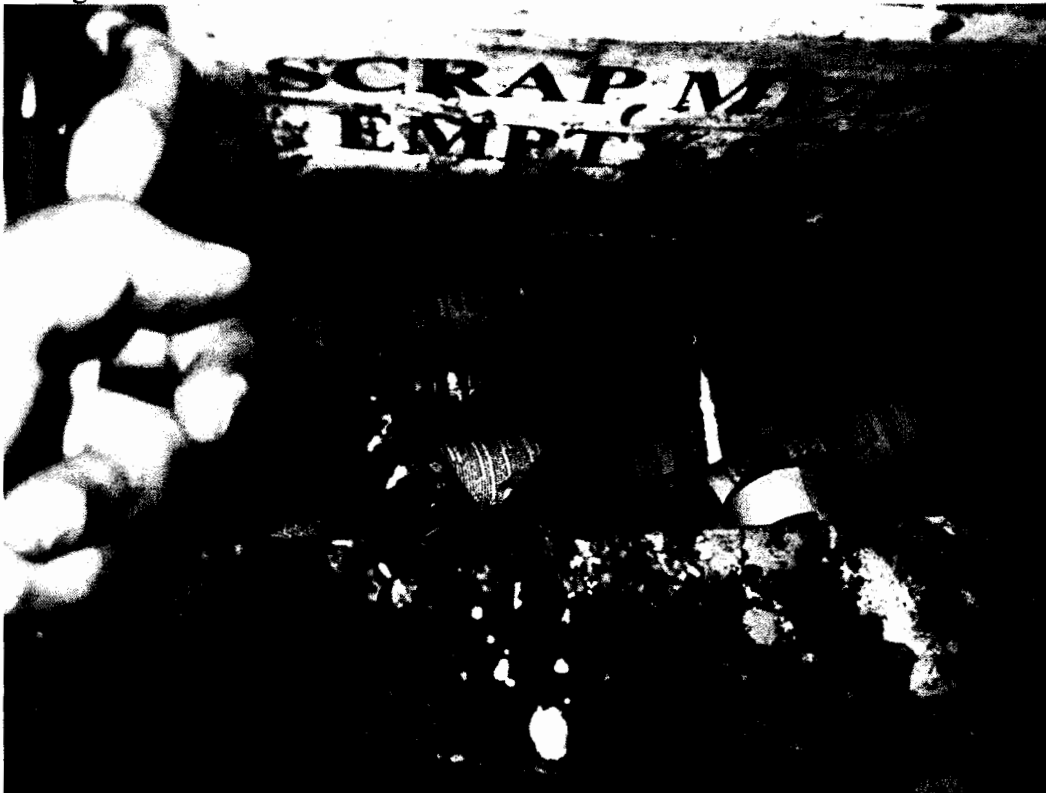
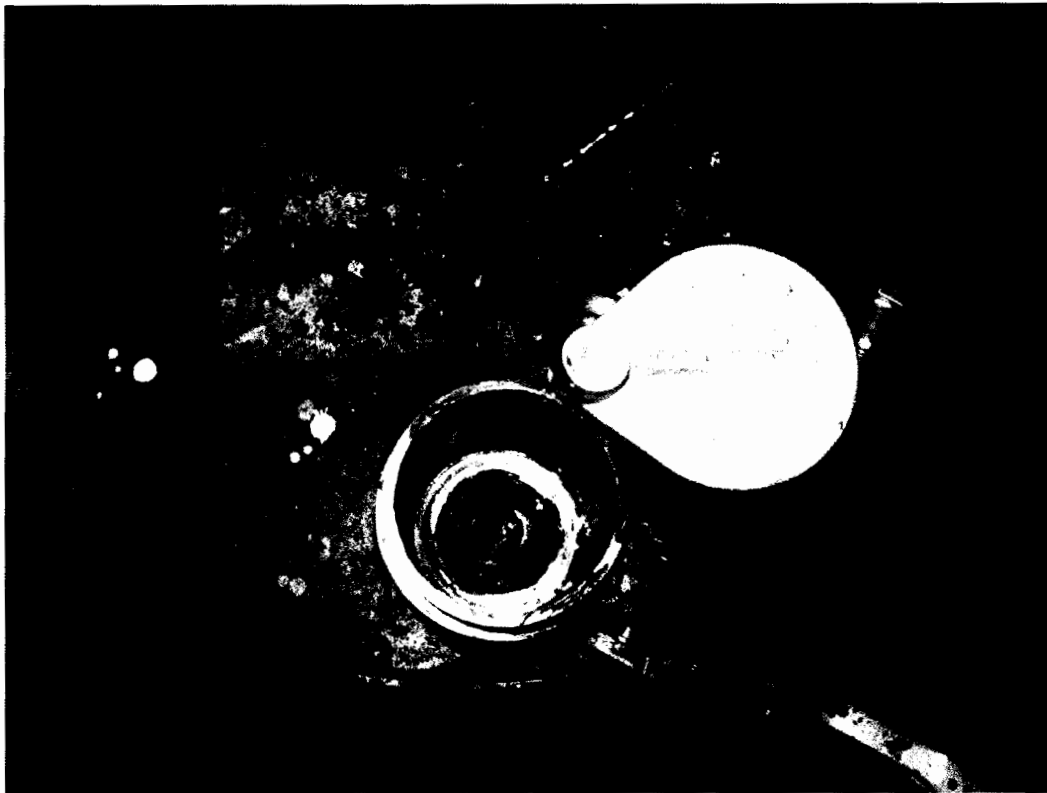
Photo 27: Can puncturer and storage drum (front) and can container (rear) in Grid Storage/HW Room

Photo 28: View inside can container from Photo 27

Photo 29: View from top of can puncturer in Photo 27 -- open

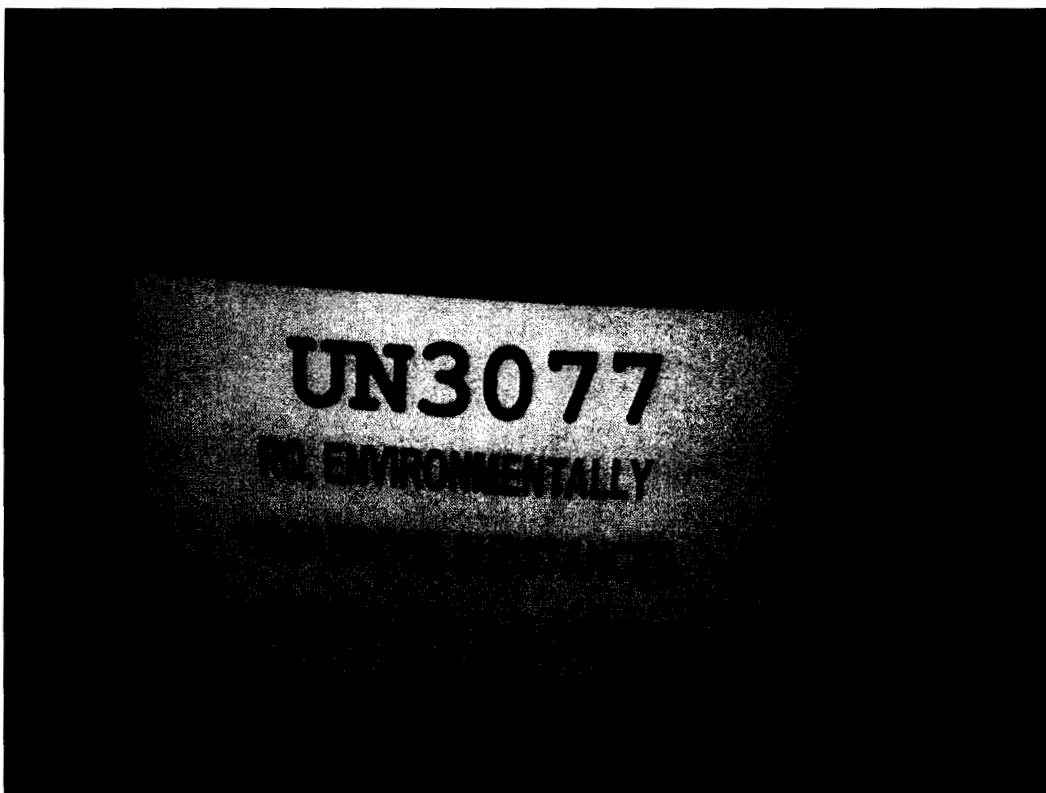
Photo 30: Lead-containing drums in Grid Storage/HW Room

Photo 31: Label on lead-containing drums from Photo 30

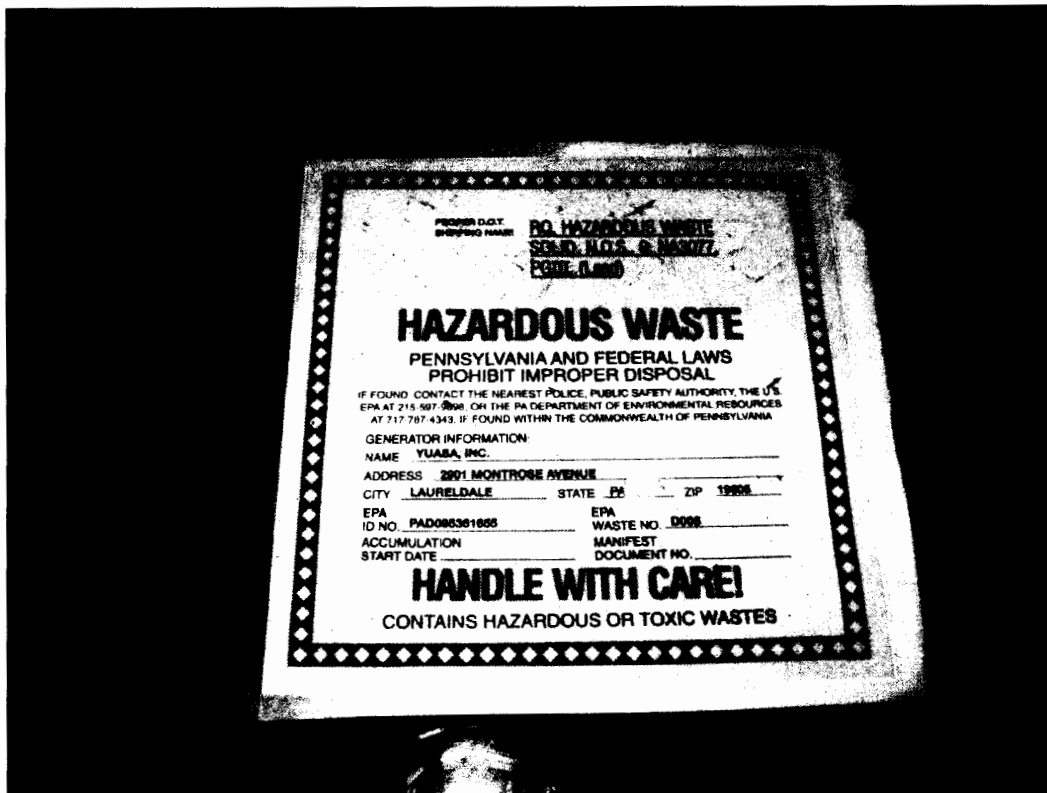
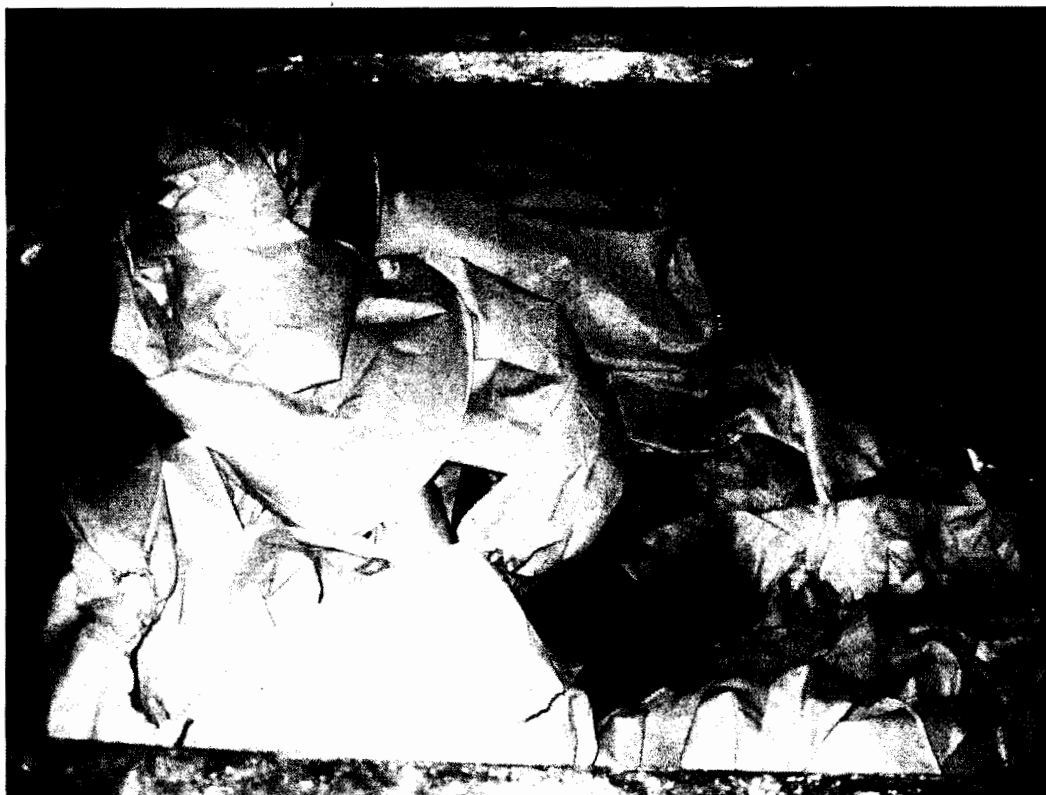
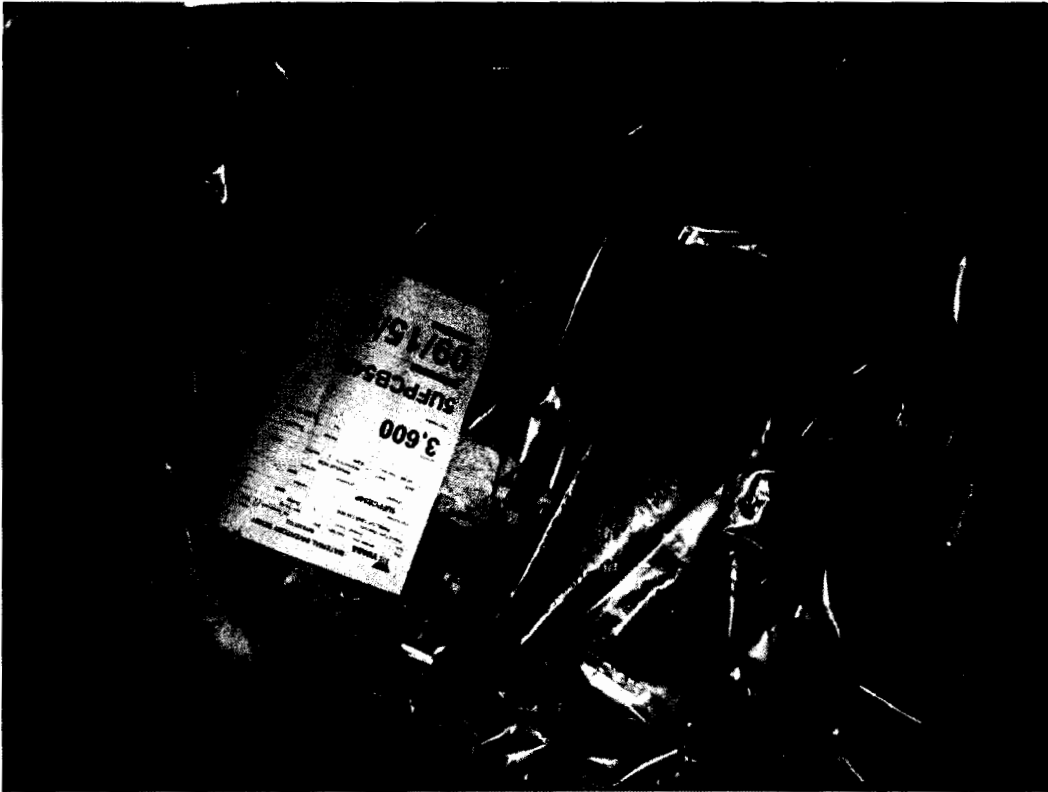
Two hoppers were found in the Pasting Department area, both labeled as containing HW D008 and undated (Photos 32 & 33). One of these hoppers was over half full of used PPE (Photo 34), whereas the second one was almost empty (Photo 35).

Photo 32: Two HW hoppers in Pasting Dept, labeled as HW D008

Photo 33: Close-up of label from Photo 32 hopper on right -- no date

Photo 34: View inside Photo 32 hopper on right

Photo 35: View inside Photo 32 hopper on left
